Technical Report 15-12

Performance of the Automatic Balloon Launcher of Radiosonde Station 04360 Tasiilaq, November 2012 – June 2015

Ellen Vaarby Laursen

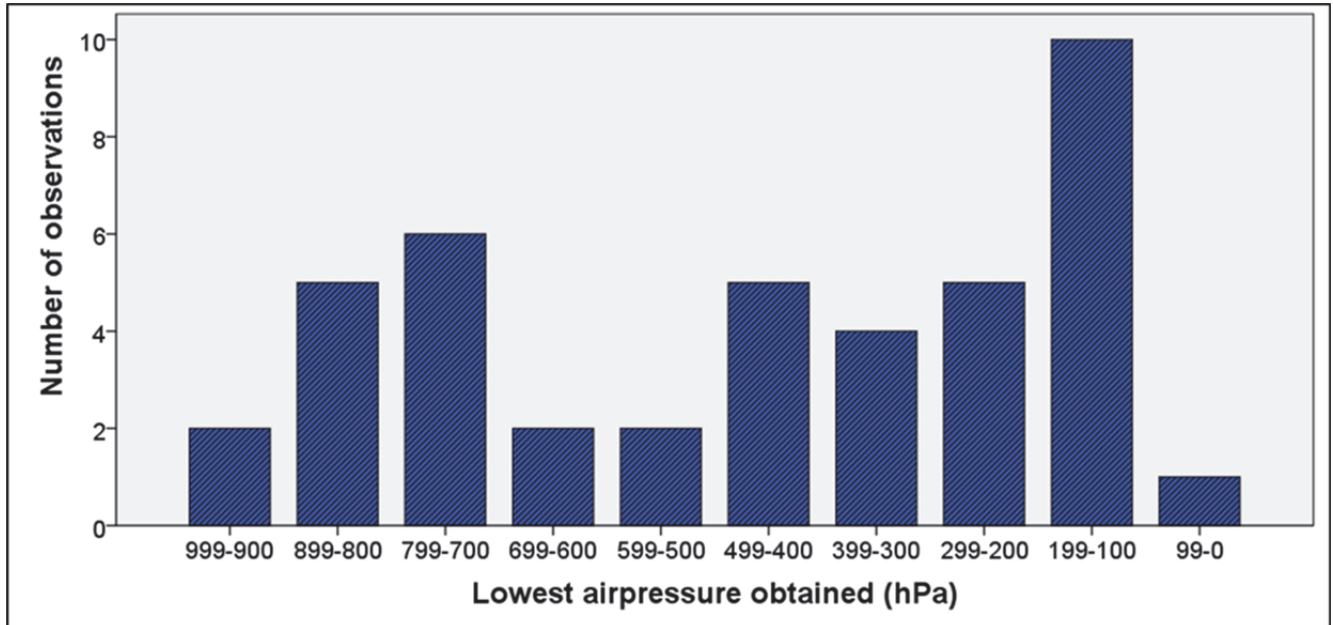
Figure 3 shows more details behind the 41 instances of known causes of low height obtained listed in Table 4 as being explicitly recorded during the January – June 2015. From Figure 3 the problem appears to be severe, as it was seen that during the 41 instances of this most recent period,

January – June 2015, half of these obtained only 300 hPa or higher pressure and nearly a third only 700 hPa or higher, as the lowest value.

Figure 3. Distribution of lowest obtained airpressure of the 41 observations during the period January – June 2015 reported by cause in Table 4.

Based on the identified cases where the connection to the radiosonde was lost before burst, the following should have the greatest impact to improve height obtained (prioritized):

1. Fixing of communication problems between ABL installation and radiosonde (cf. Table 4).
2. Radiosondes with more reliable temperature sensors (cf. the kind of sensor failure resulting in a bulletin sent before burst shown by example in Figure 7).

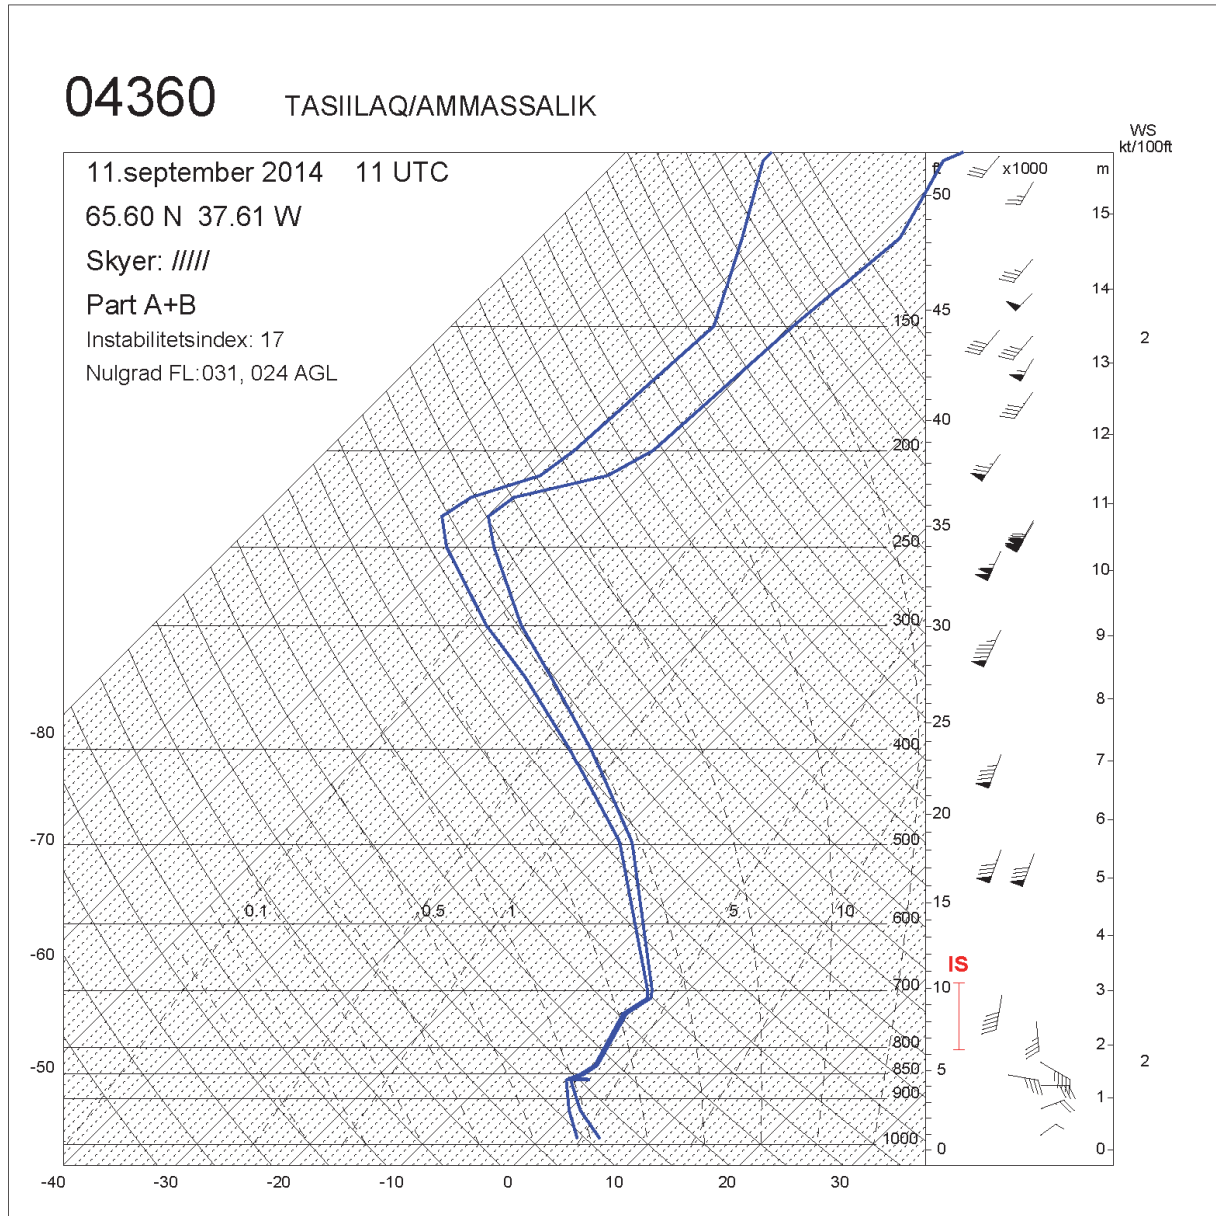
Figure 4 Example of radiosonde observation evaluated as 'Immediately unrealistically high humidity in the stratosphere'

1. Employ radiosondes with more reliable humidity sensors.

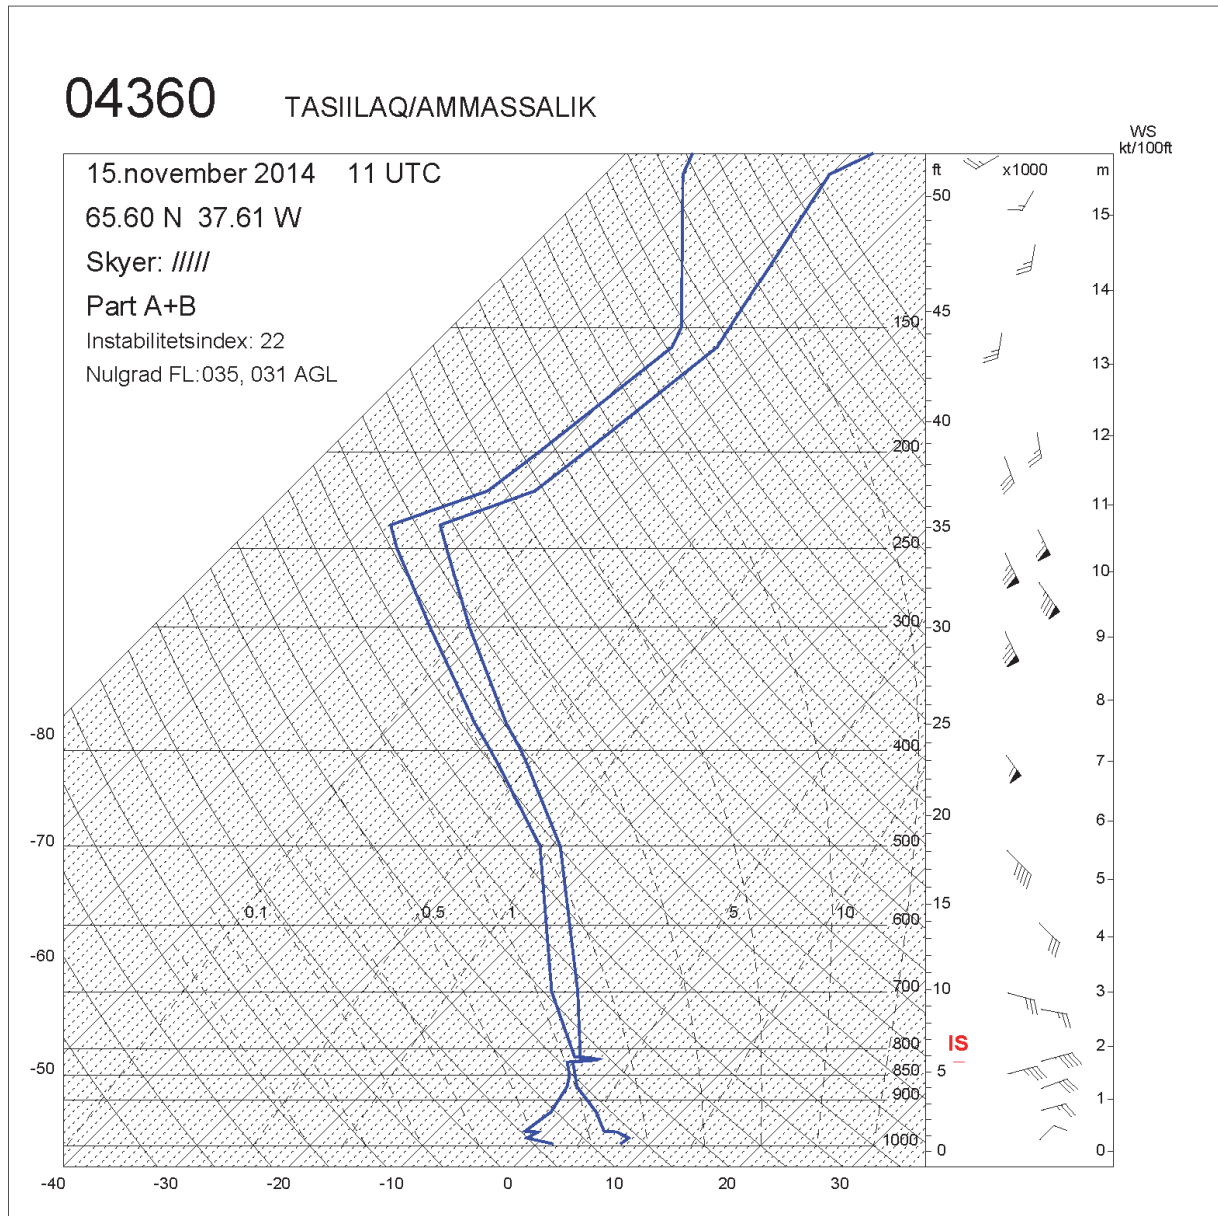
Figure 5 Example of radiosonde observation evaluated as both 'Immediately unrealistic 'parallel course of Dew point and Temperature'' and 'Immediately unrealistically high humidity in the stratosphere'.

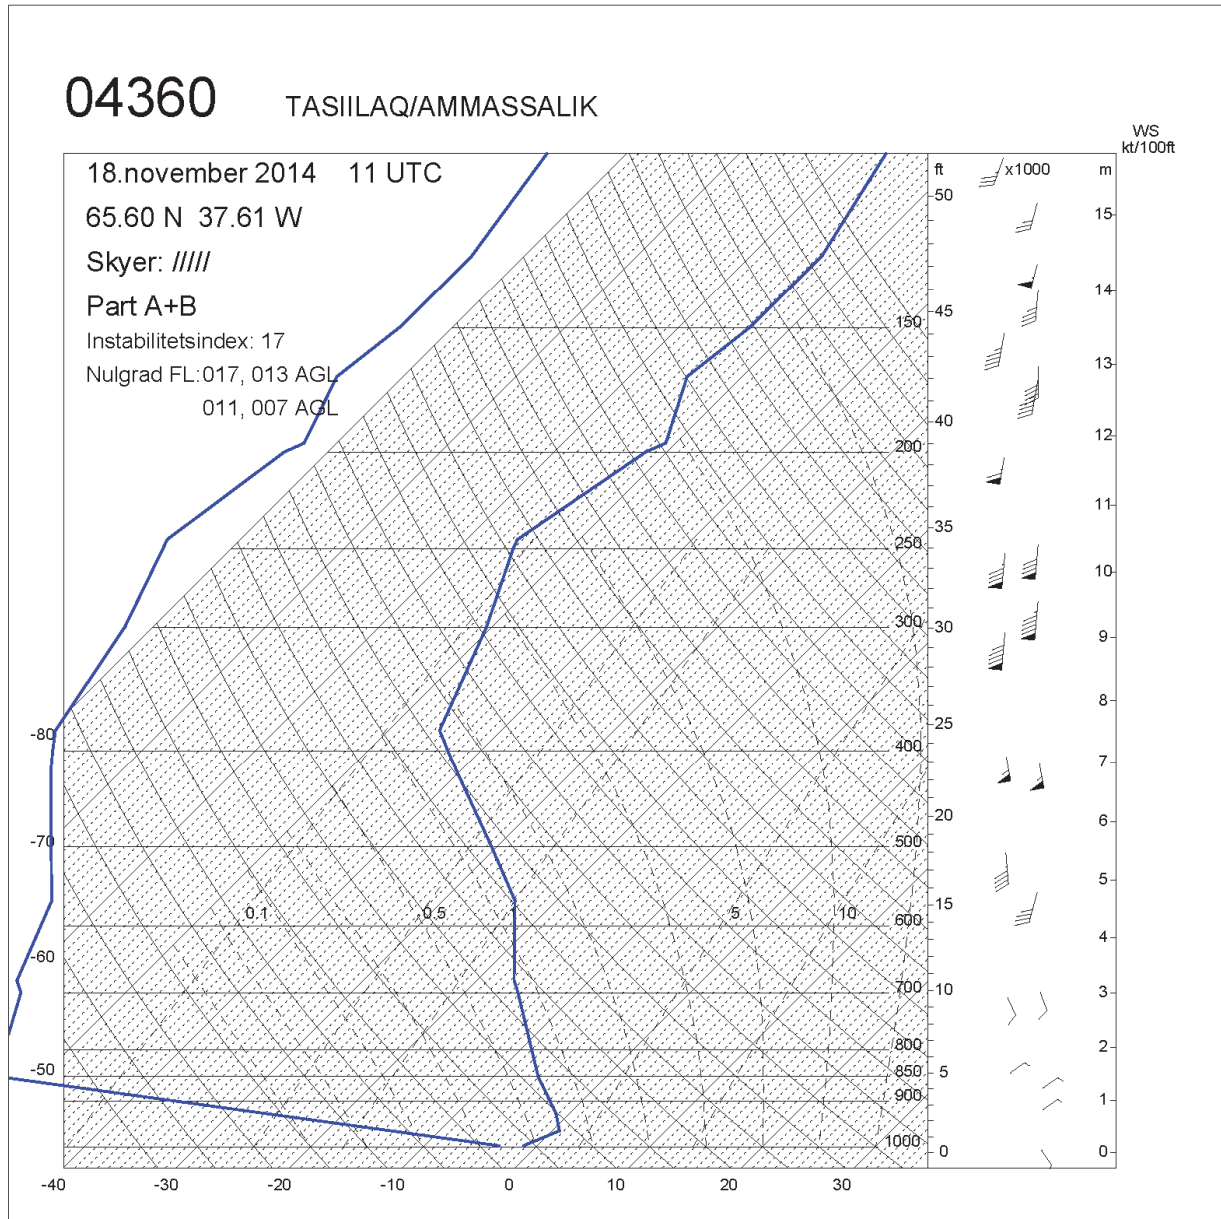
Figure 6 Example of radiosonde observation evaluated as 'Immediately unrealistically dry radiosonde (Dew point and temperature almost doesn't meet when there are clouds)'.

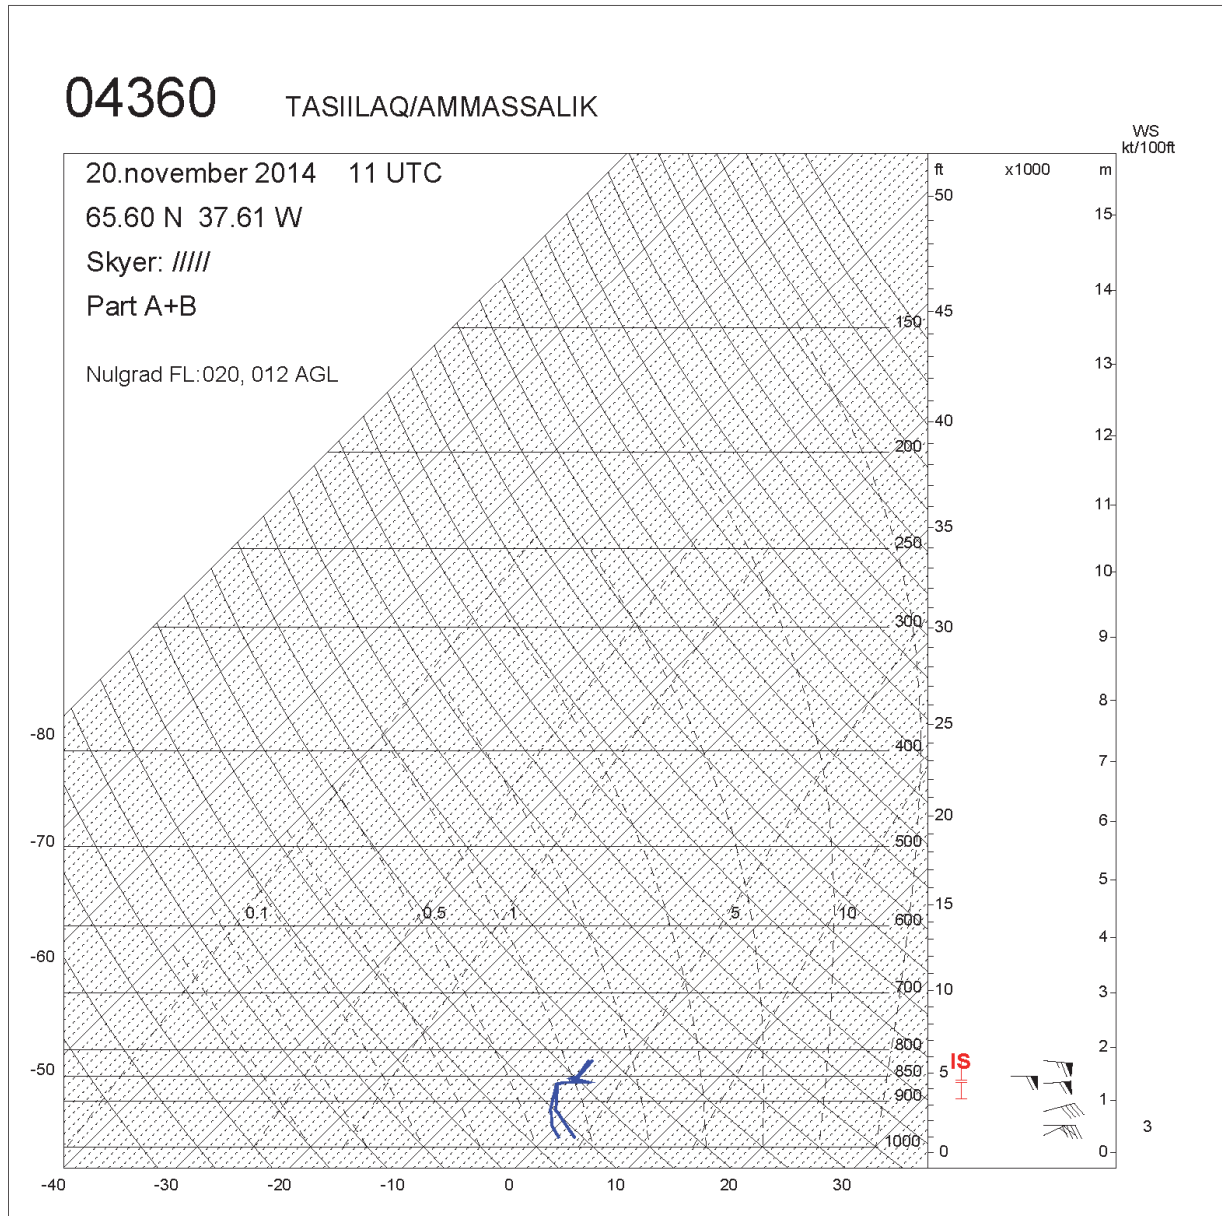
Figure 7. Example of radiosonde observation evaluated as 'Not immediately OK' because of insufficient height obtained. I.e. the bulletin of this particular launch was sent before burst, because of failure of the sonde temperature sensor at 1521 m 815,6 hPa. This information may be looked up in ANNEX B, in the column 'Print outs from robot sonde log file' for the hour of observation 20 November 2014 12 UTC.

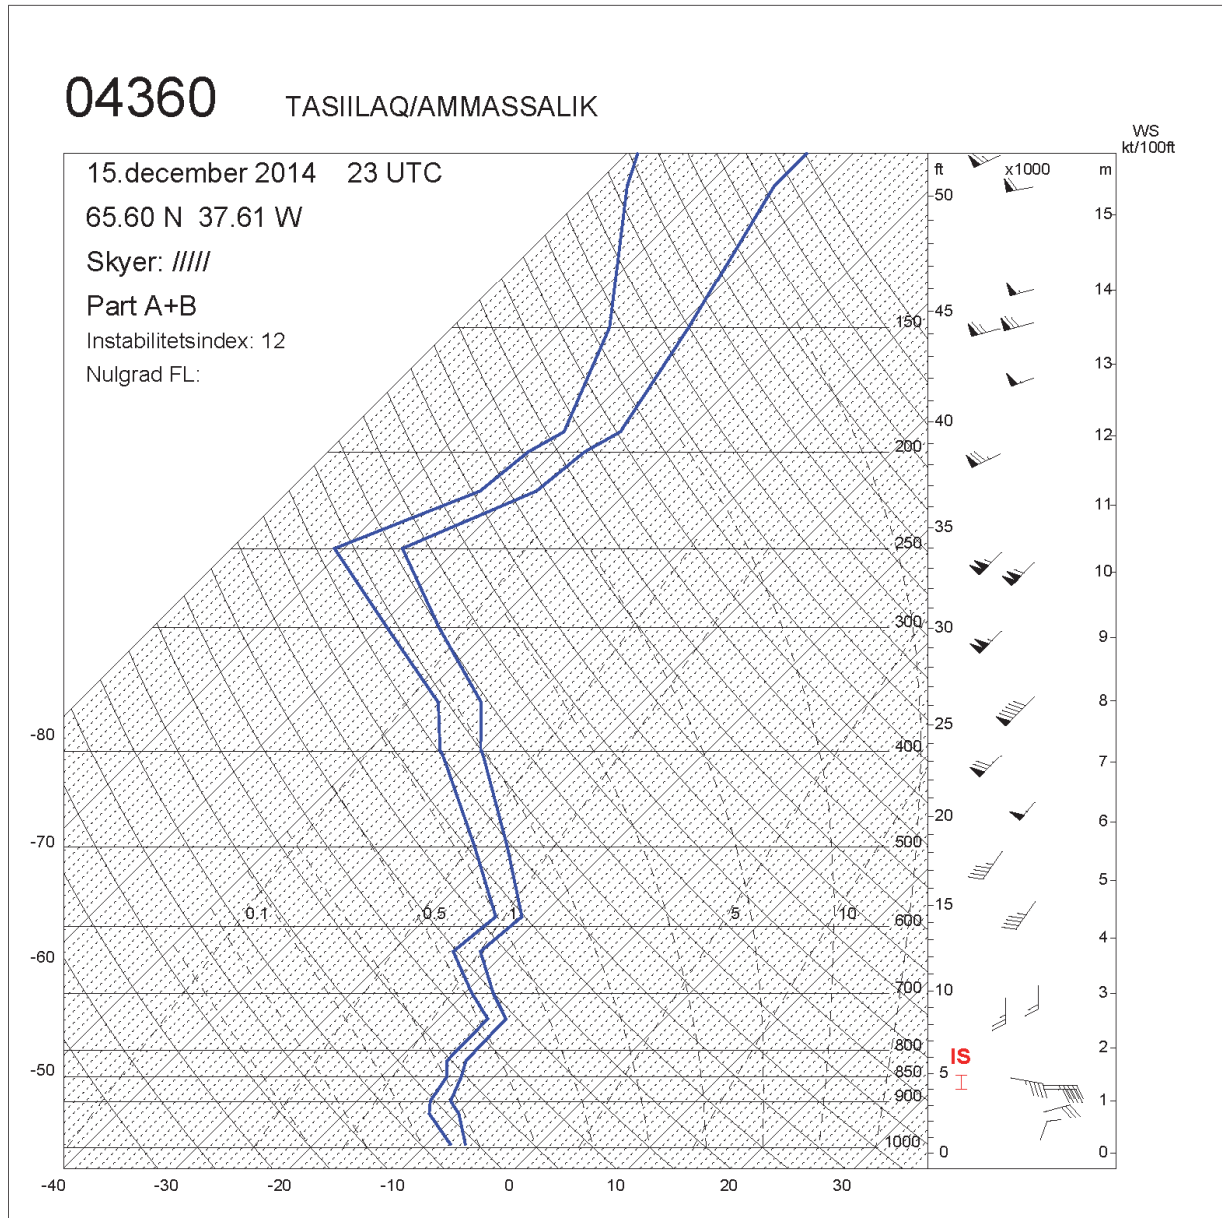
Figure 8 Example of radiosonde observation evaluated as having 'Immediately unrealistic 'parallel course of Dew point and Temperature''.
